Bicycle Hazards at the Ohlone Greenway Path Entrance From Masonic (in Albany, CA)

Some photos of the current bike path access point from Masonic/northbound (taken on February 6, 2008). I think they illustrate some TLC and housekeeping to make it even possible to get onto the path from Masonic?

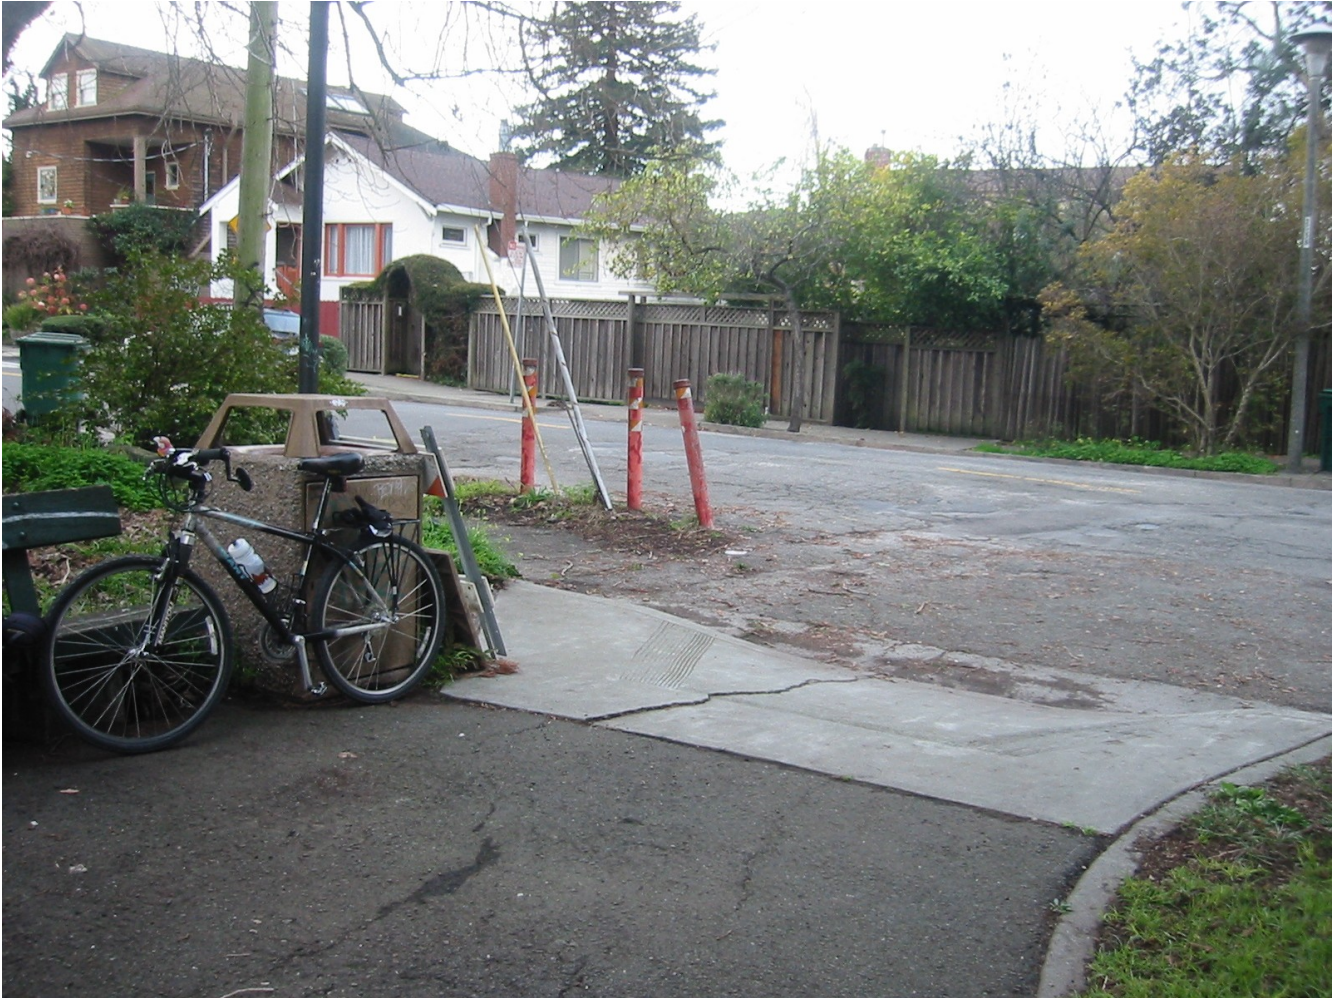
Fig. 1: Patchy pavement, debris & orange "bollards" on the street immediately beforehand make the entry point from Masonic to the path difficult, especially at night (which is when people need to use it commuting northbound)

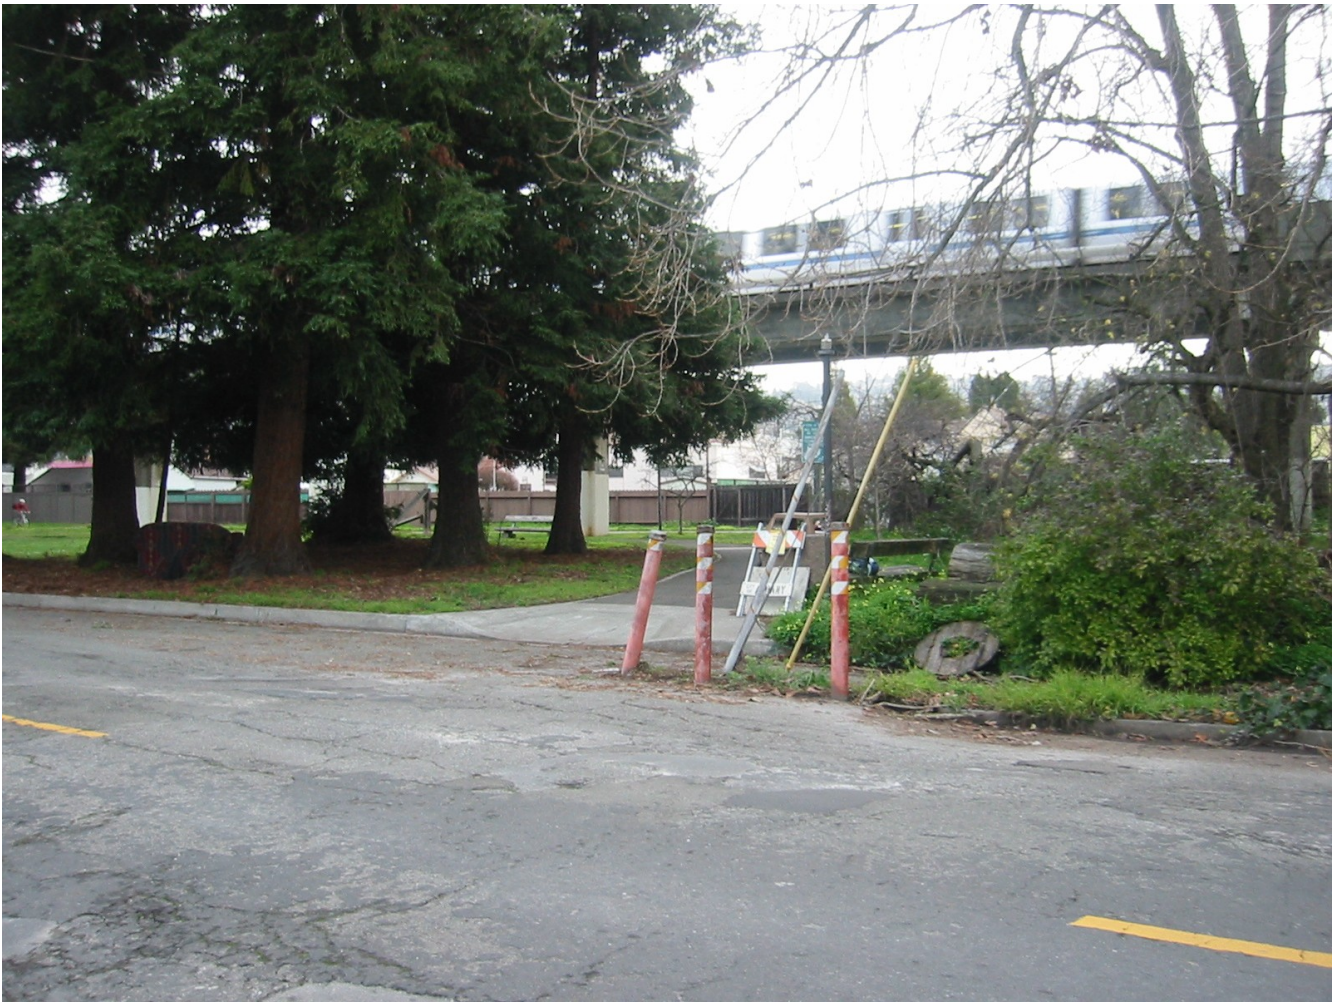
Fig. 2: another view, from across the street. Notice that the path is on the Albany side of the creek.

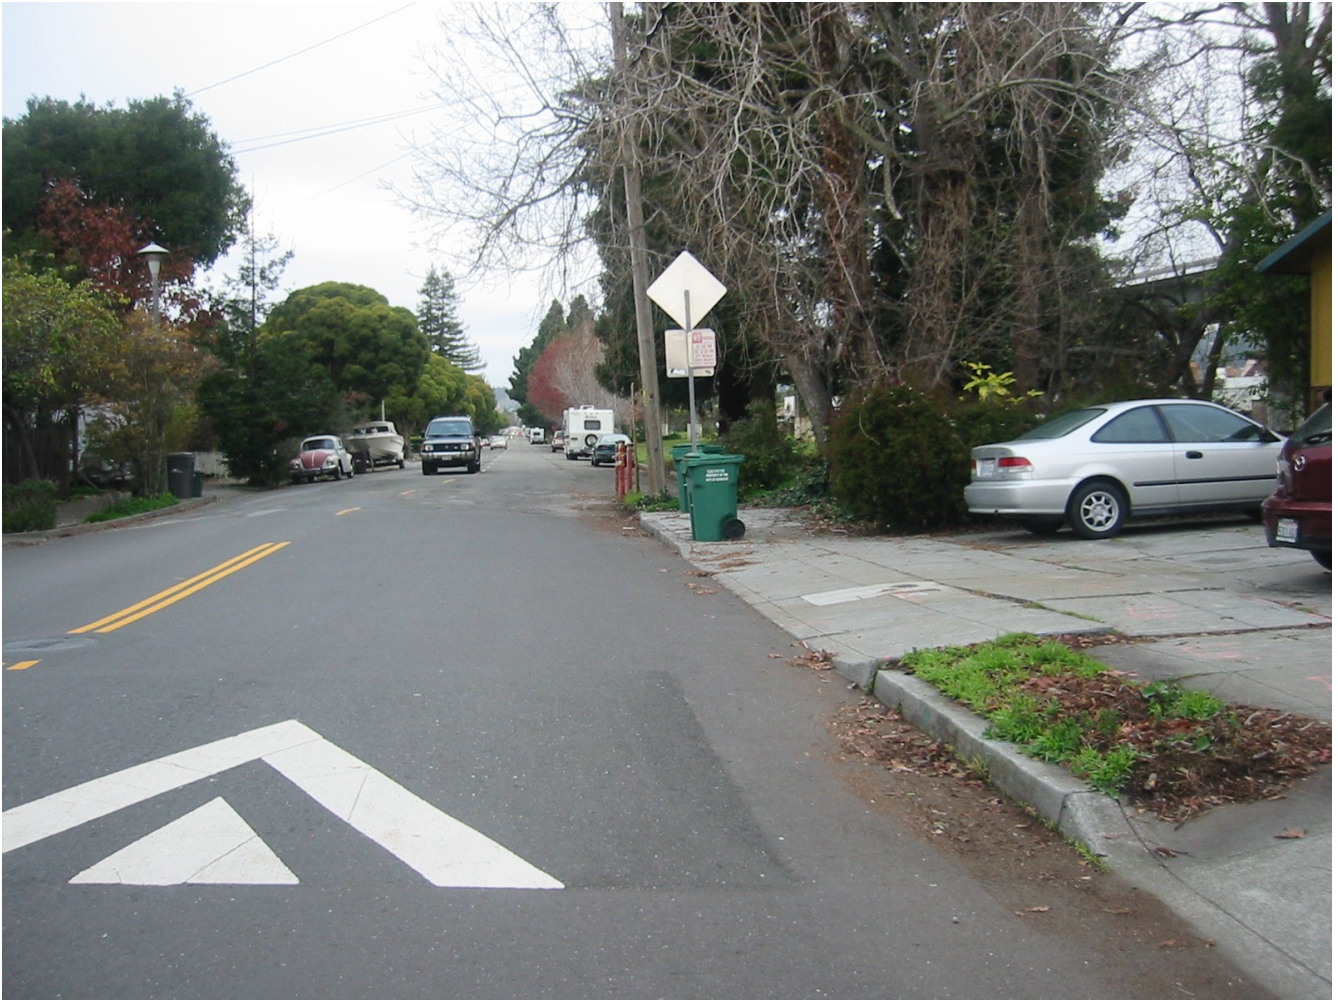
Fig. 3: Approaching from the south, about 25 ft away from entrance. Note that usually there is a car parked immediately adjacent to the traffic hump (near-side curb) in the evening. Further up, by the trash cans, that's a "No Parking" sign, but the No Parking hours are 12:30 pm - 3:30 pm, 2nd Monday of the month (i.e, only for street sweeping hours).

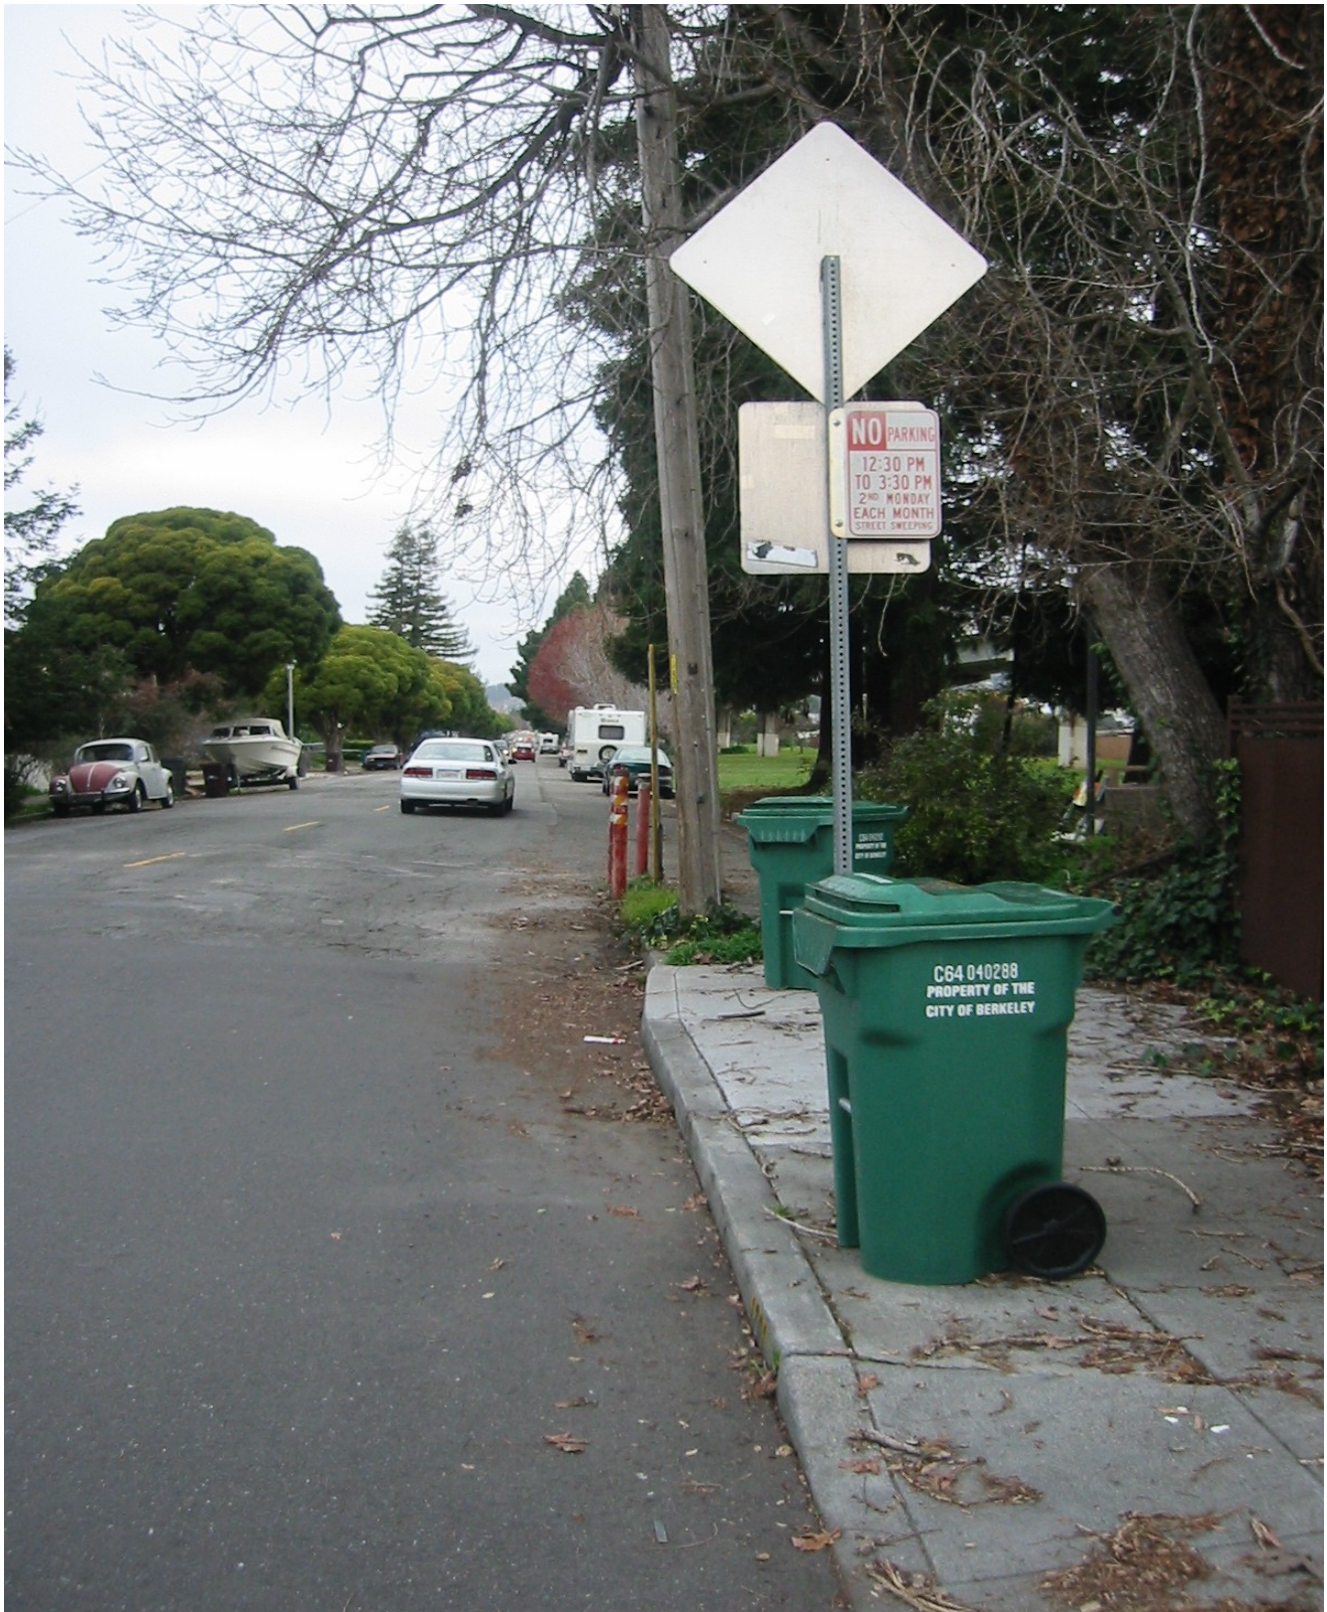
Fig.4: No parking sign indicating parking allowed anytime except for two hours during street sweeping hours, mid-day, 2nd Monday of each month. Also, it appears that this small area also falls in the "no man's land" between both street cleaning and road maintenance/repair jurisdictions for both Albany and Berkeley? Note the very bad pavement conditions immediately adjacent to the path entrance (in background).

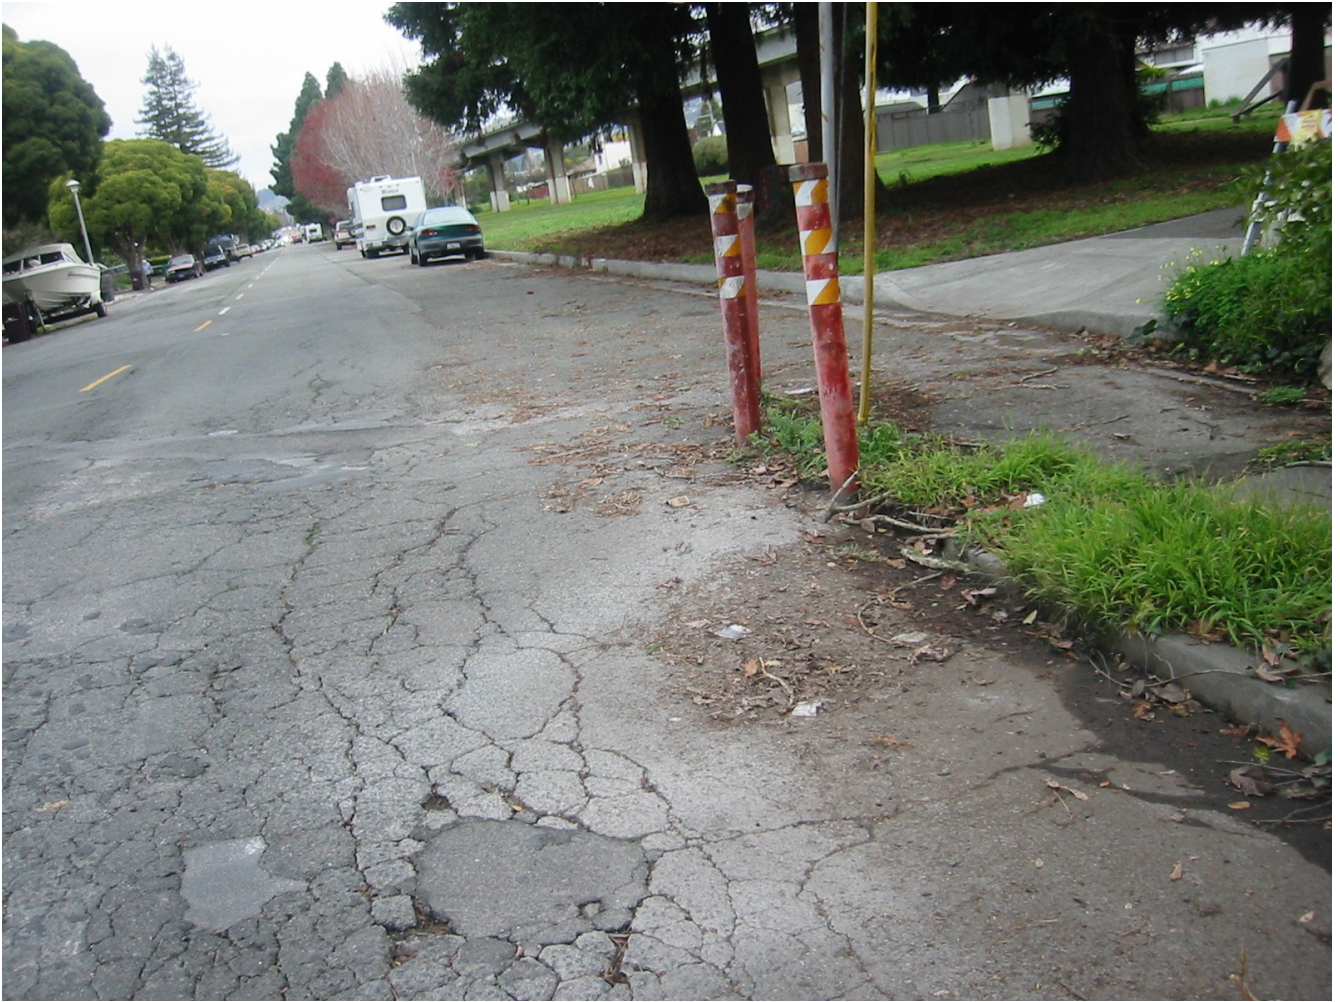
Fig. 5: Imagine this at night!

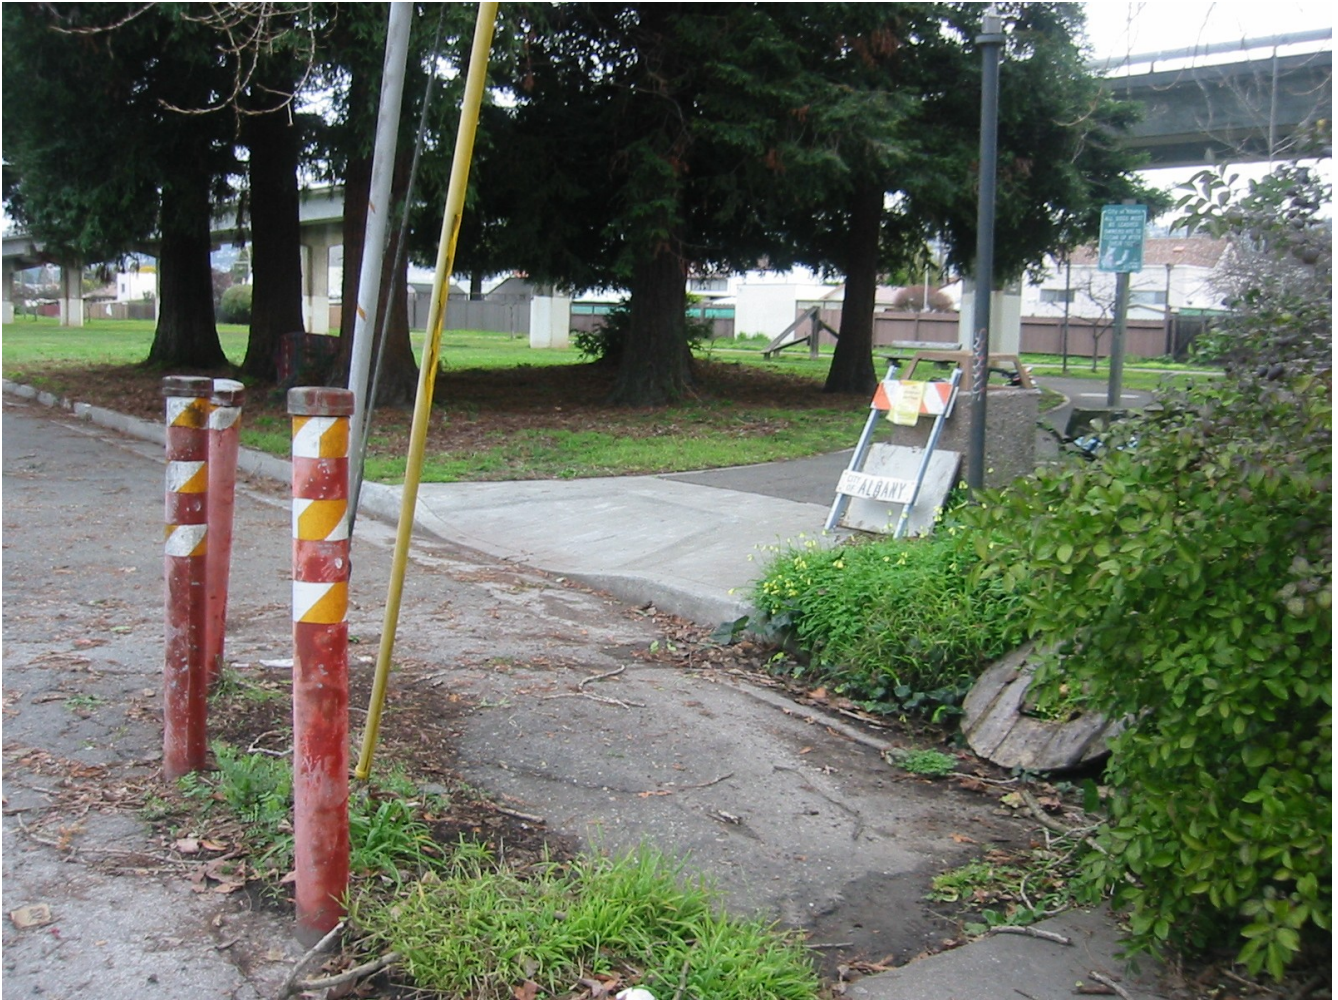
Fig. 6: Another indication of the almost impossible access to path.

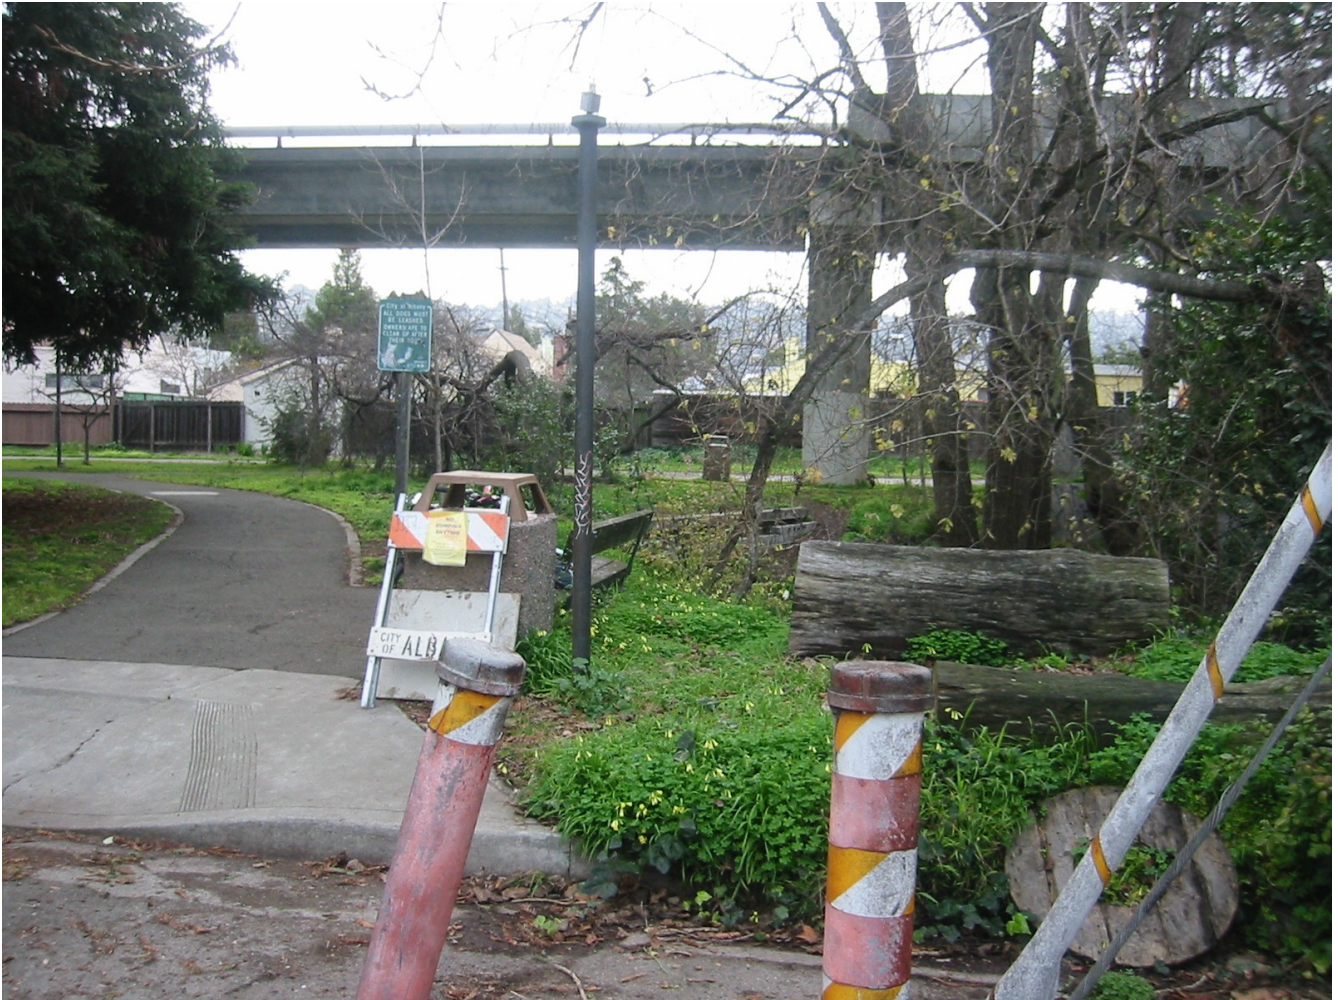
Fig. 7: Path entrance: North of the Creek, i.e.: Albany jurisdiction. Also note the Sign on the traffic/construction marker: "City of Albany"

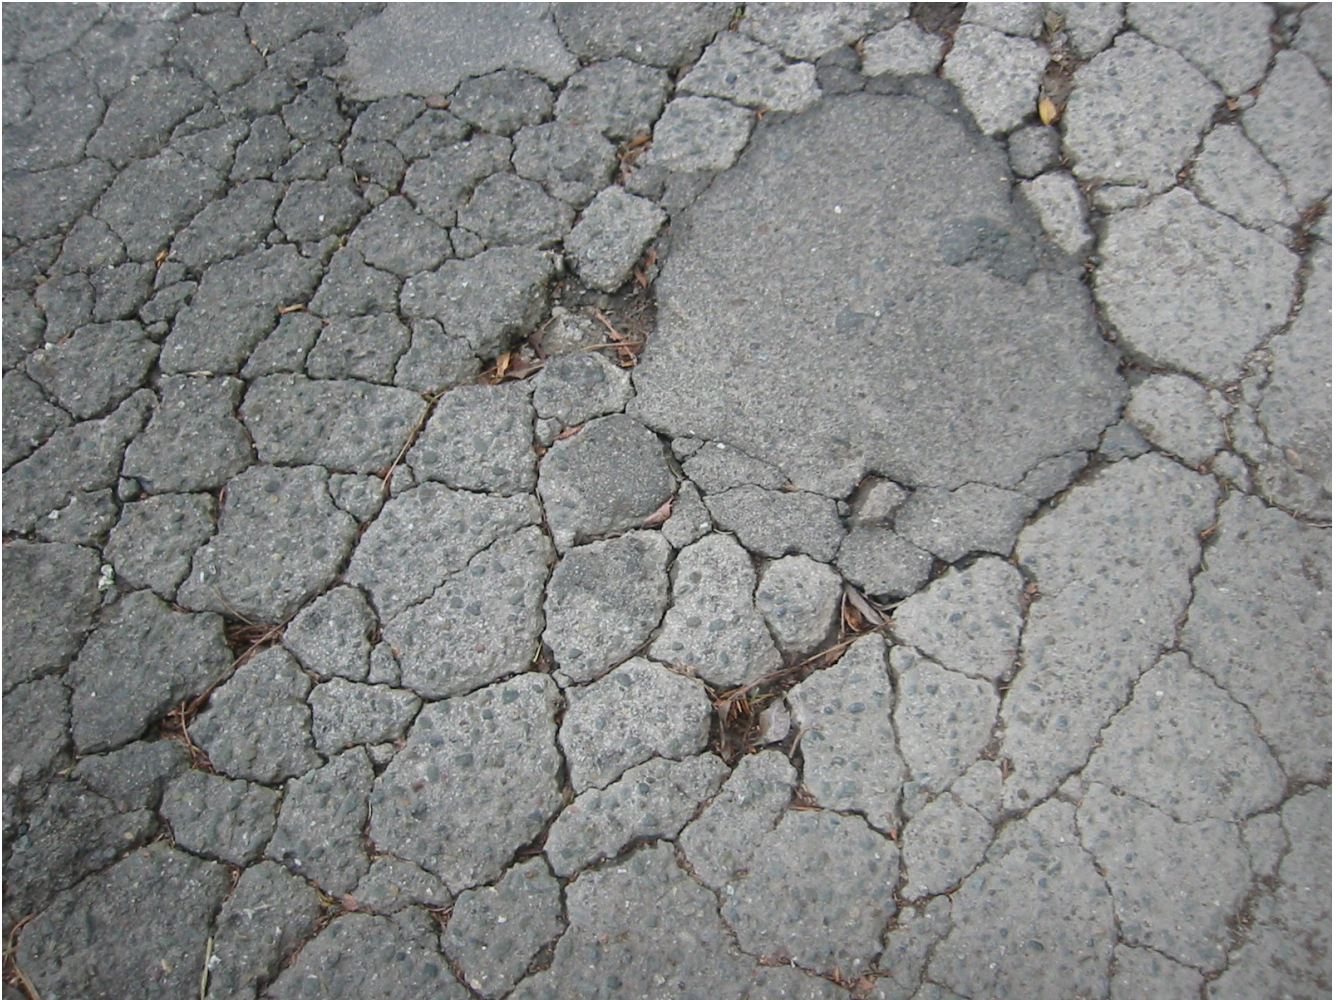
Fig. 8: Closeup of poor pavement condition immediately in the access point on street

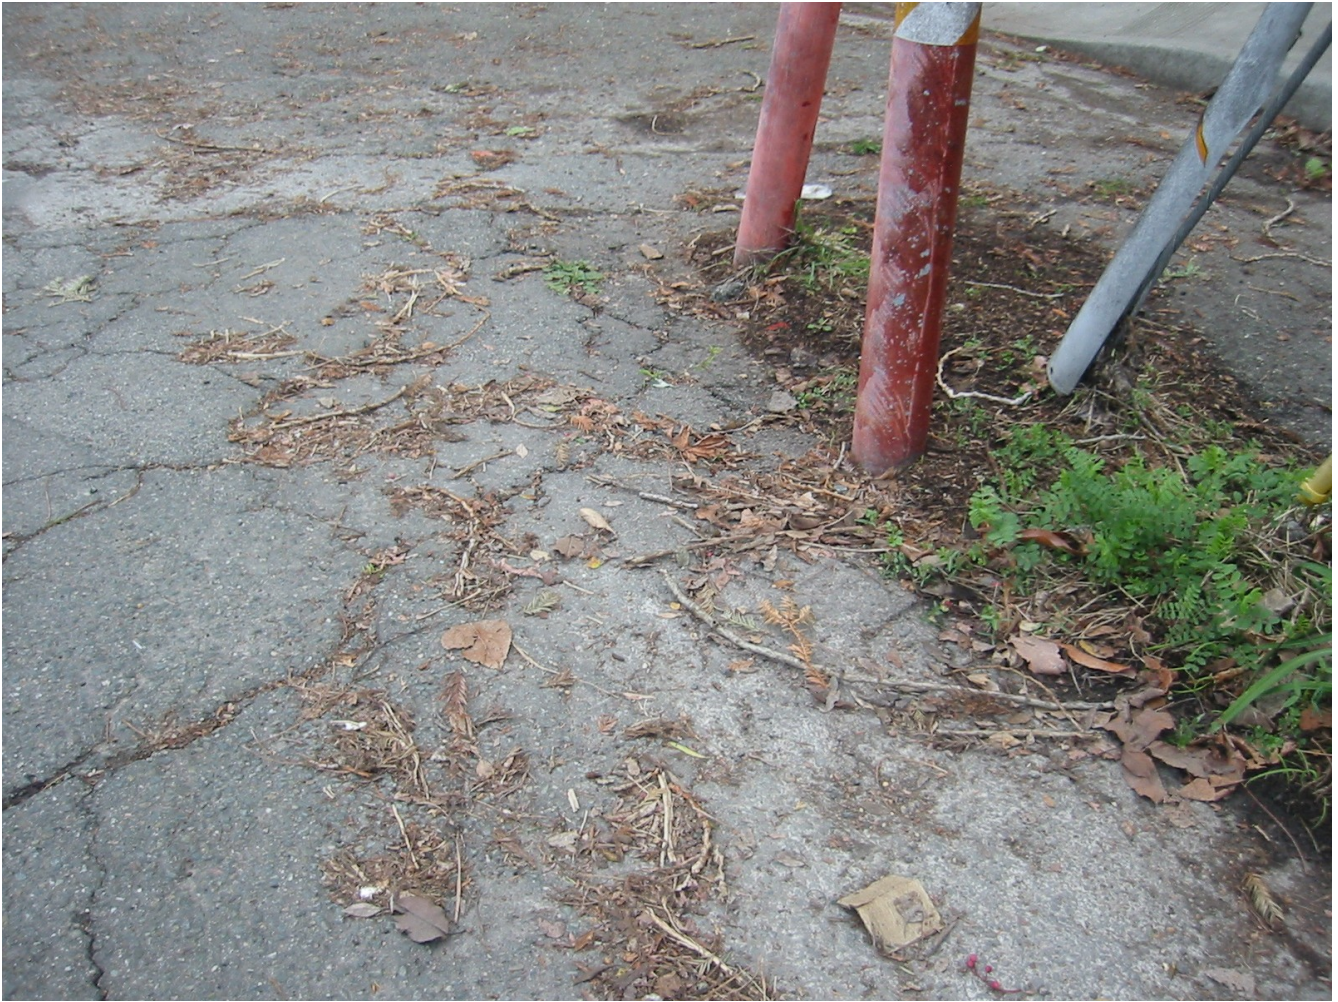
Fig. 9: More debris right by the entry point to the path

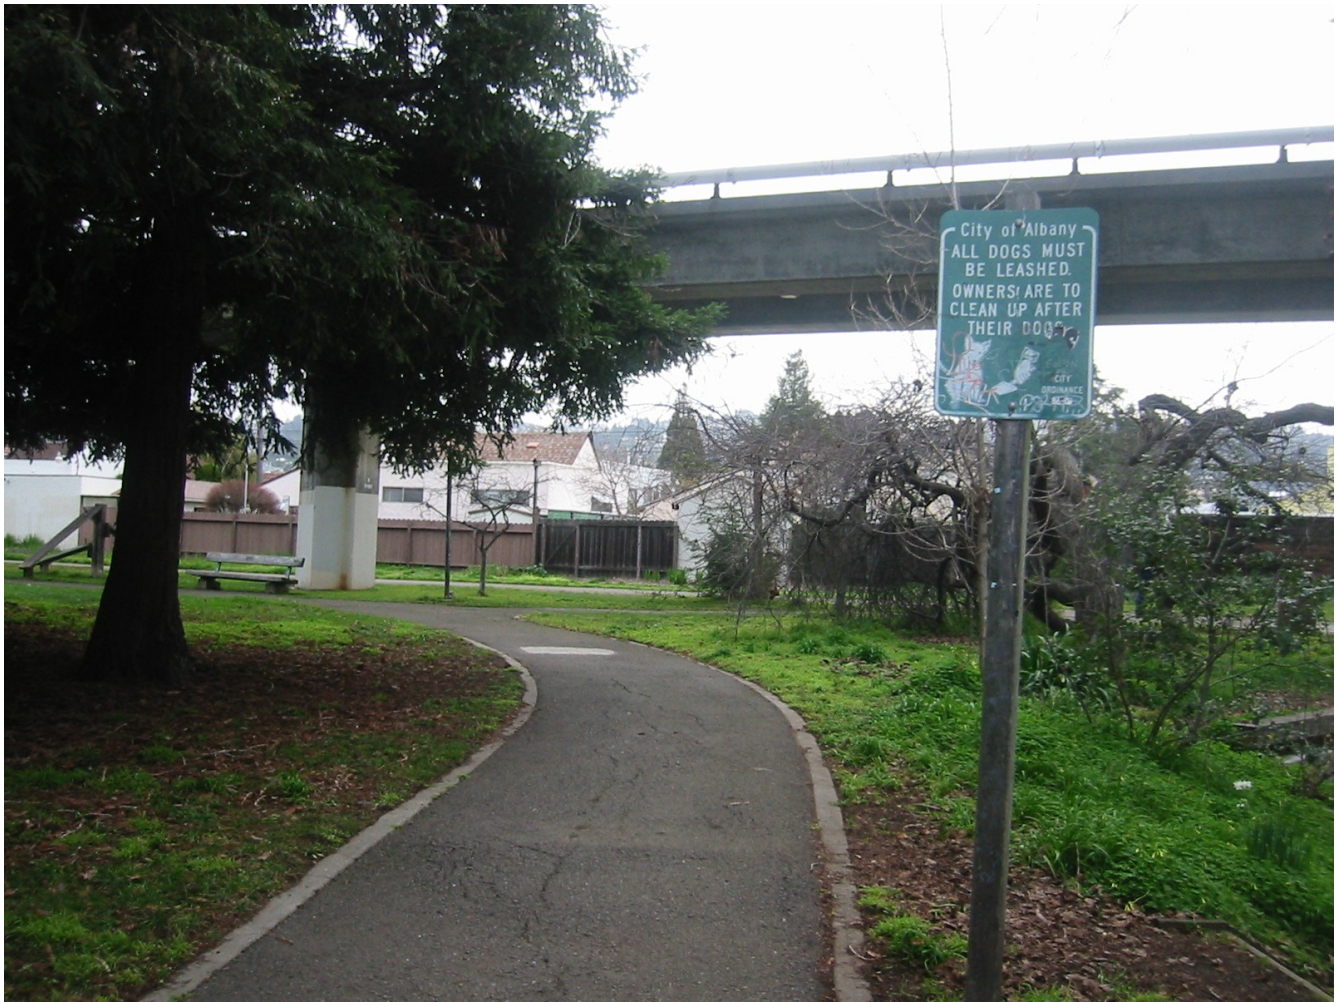
Fig. 10: "City of Albany: All Dogs Must be on Leashed." Uh, huh??

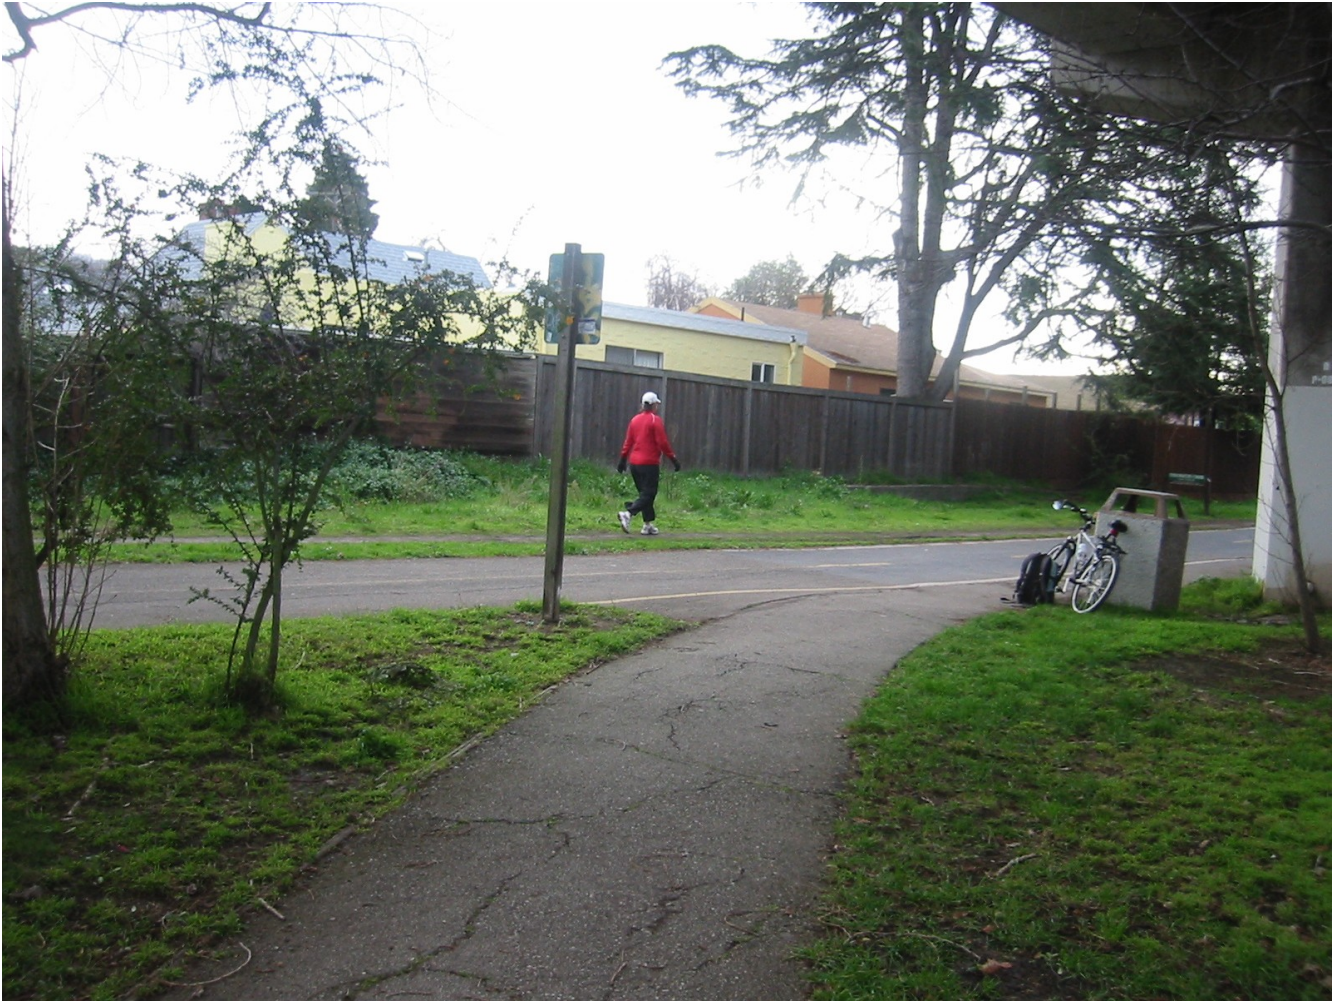
Fig. 11: Tricky hairpin turn to get back heading Northbound on bicycle path

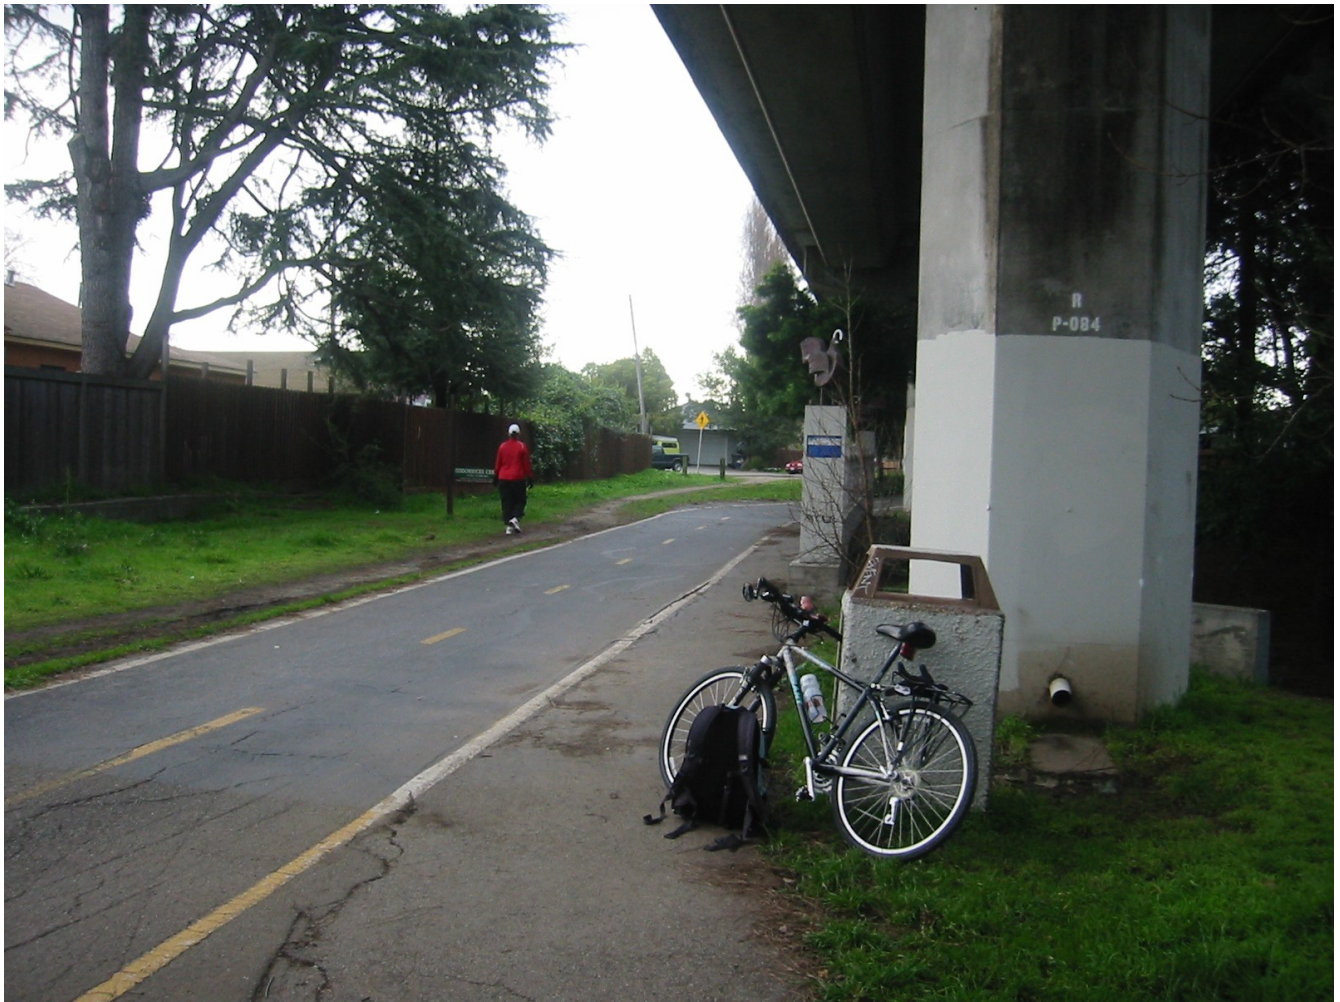
Fig. 12: shared bike/ped path (southwest bound) merging with bike path; peds are forced to the narrow strip on the right, which then ends narrows and ends abruptly in the middle of the creek overcrossing. Suggestion for the eventual reconfig: the path can maybe veer to the left a bit at this point to give those merging from the right some room?

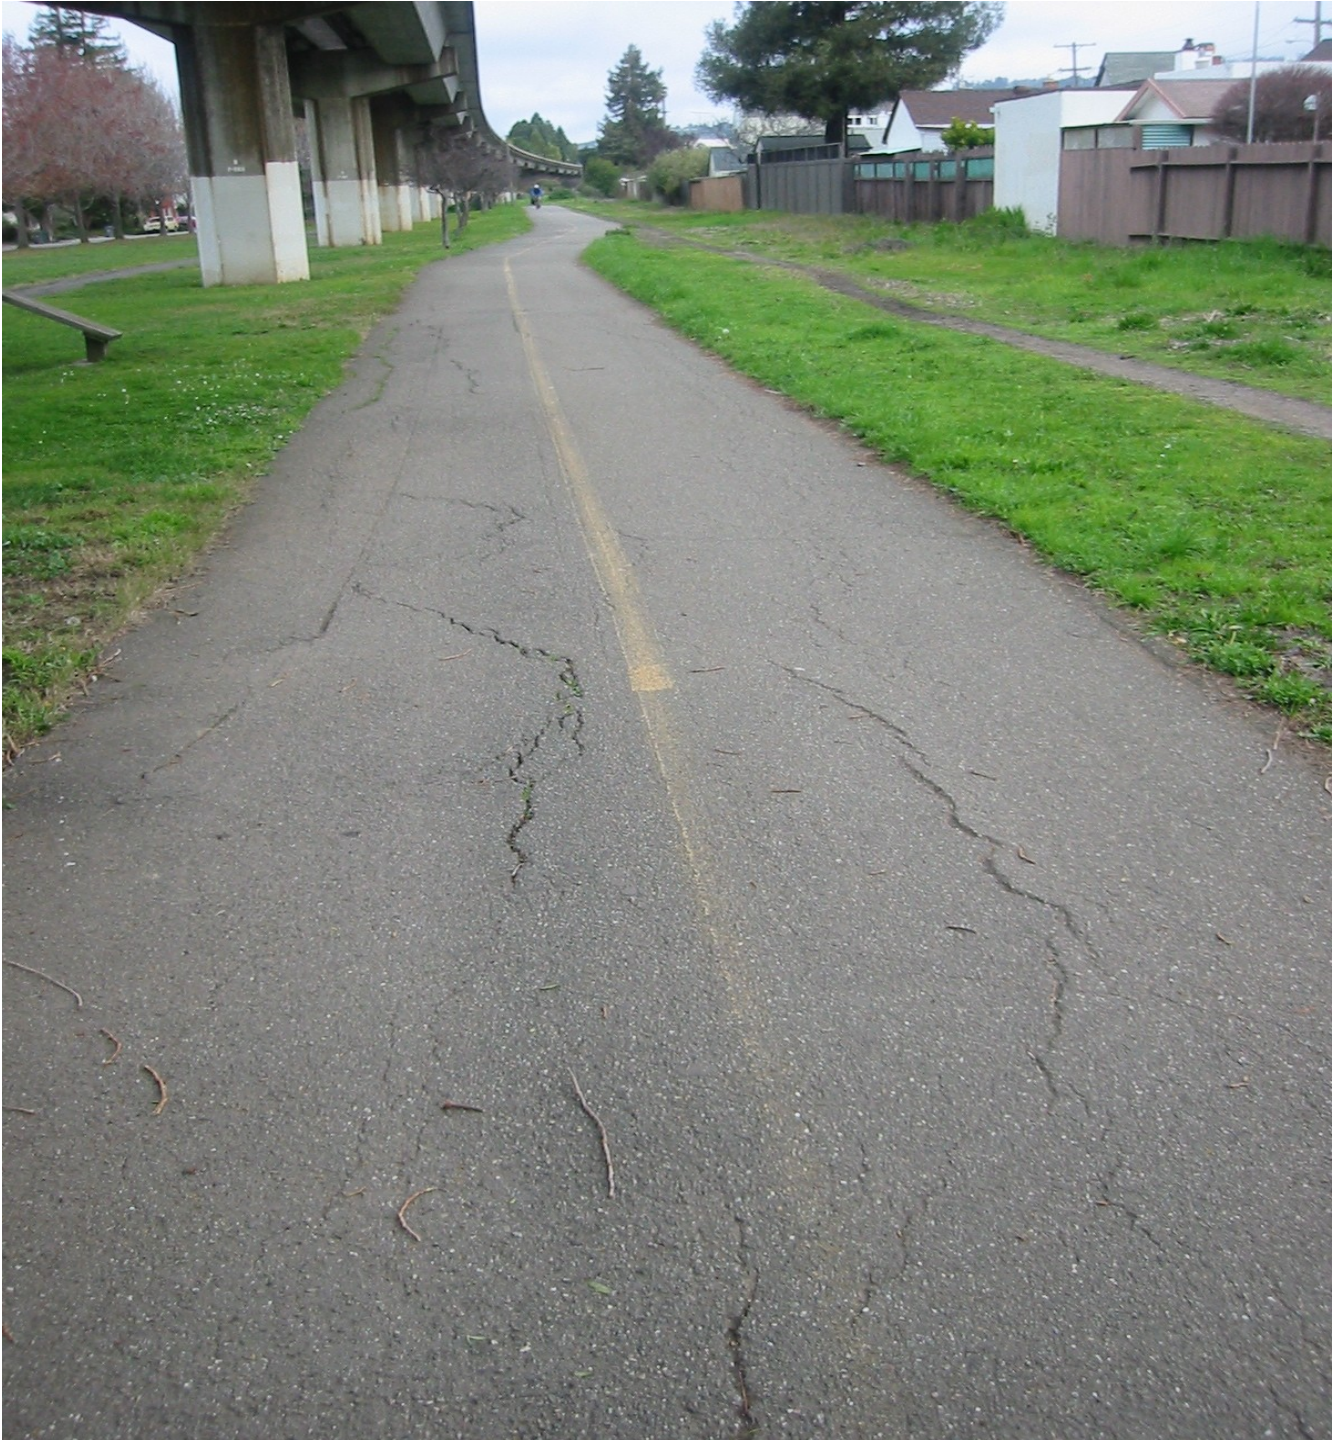
Fig. 13: and last but not least, this is one of the reasons i'm not buying it when i'm told the bike path is SO MUCH smoother than the ped path (this is the bike path)
